INNOVATIVE ASSESSMENT ANALYTICAL RESULTS REPORT

Lower Silver Creek

Summit County, Utah

UTAH DEPARTMENT OF ENVIRONMENTAL QUALITY
Division of Environmental Response and Remediation
Prepared by : Ann M. Tillia

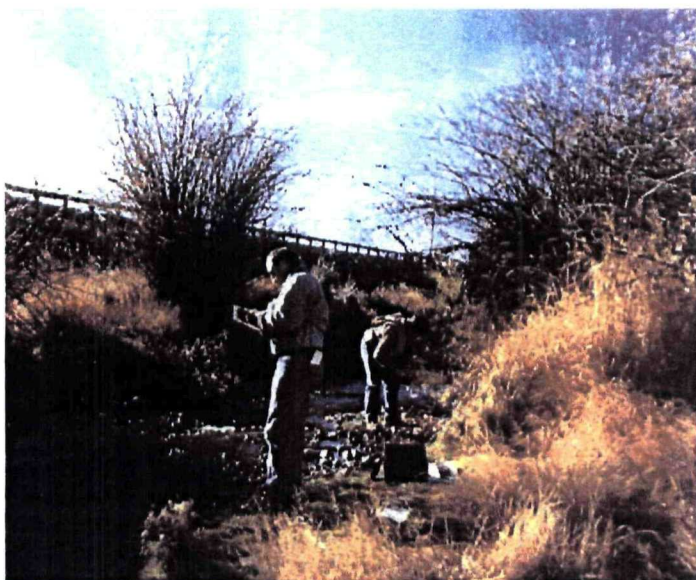
Photo 1-1. Date: 11/02/01 Sample: SD-76/SW-28.
View: Sample site above the confluence of Silver Creek with the Weber River. The I-80 is in the background.

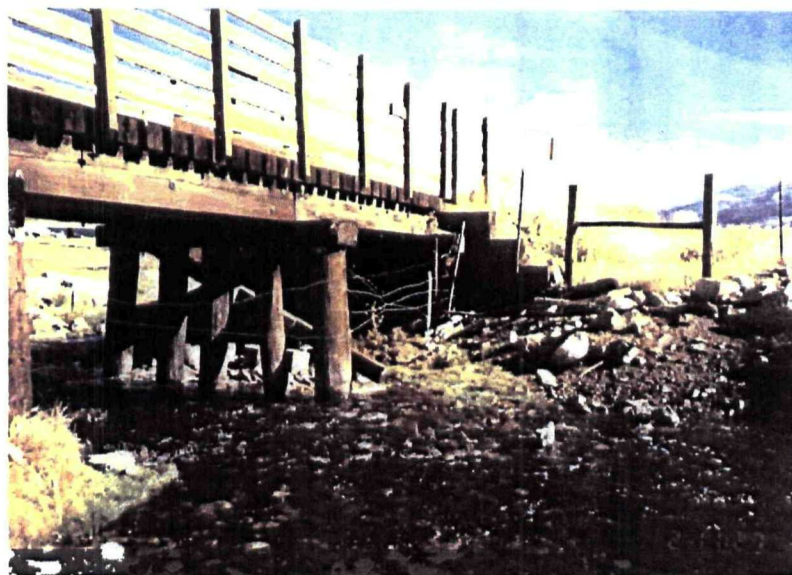
Photo 1-3. Date: 11/02/01 Sample: SD-53/SW-23
View: Samples shown in center of creek near the second bridge above Wanship.

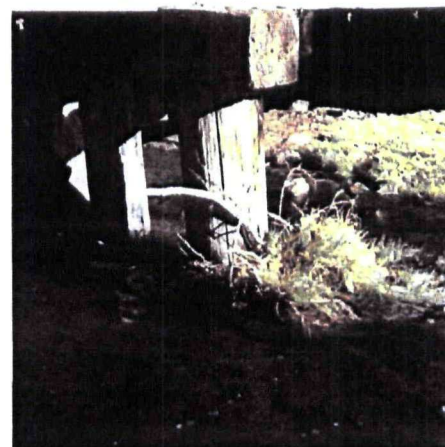
▼ Photo 1-4. Date: 11/02/01.
Sample: SD-52/SW-22.
View: Samples shown along bank of Silver Creek (see arrow). Field personnel in the background is doing stream flow measurements.

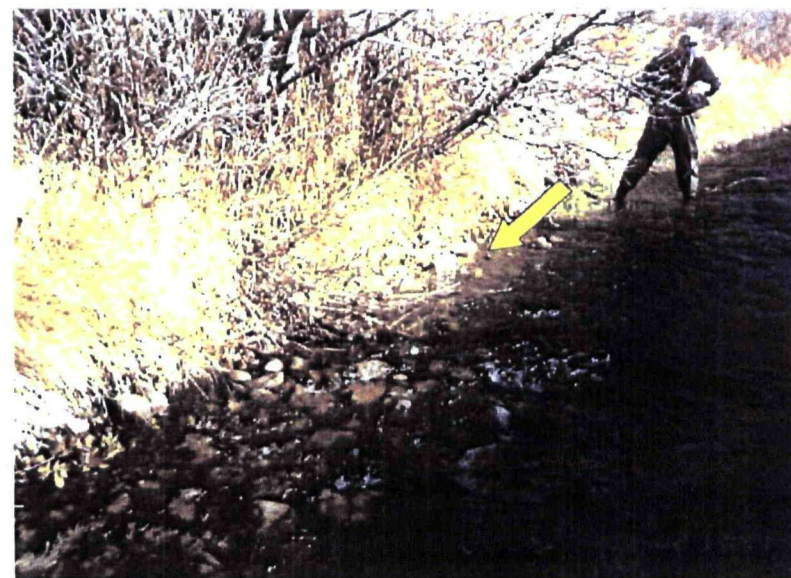
Photo: 1-7
Date: 11/02/01
View: Alexander Canyon in background and Silver Creek in the foreground. Sample site (SD-51/SW-21) is left (upstream) of the photo.

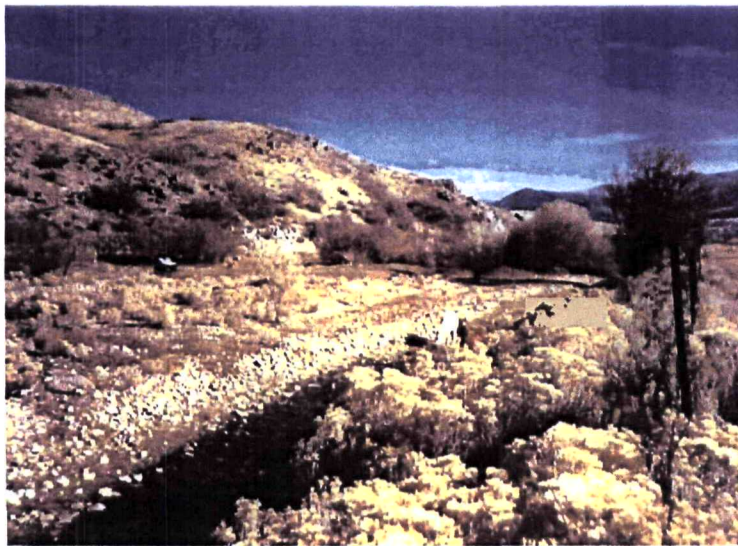
Photo 1-5. Date: 11/02/01
View: NE with horses in creek downstream of sample site (Sample: SD-52/SW-22) shown in Photo 1-4.

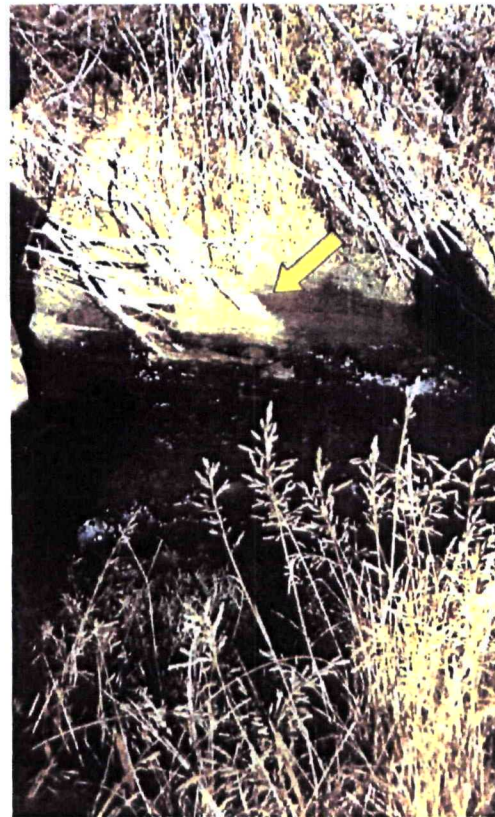
Photo 1-6
Date: 11/02/01
View: Samples on the bank (see arrow) of Silver Creek upstream from the Alexander Canyon confluence.
Sample: SD-51/SW-21

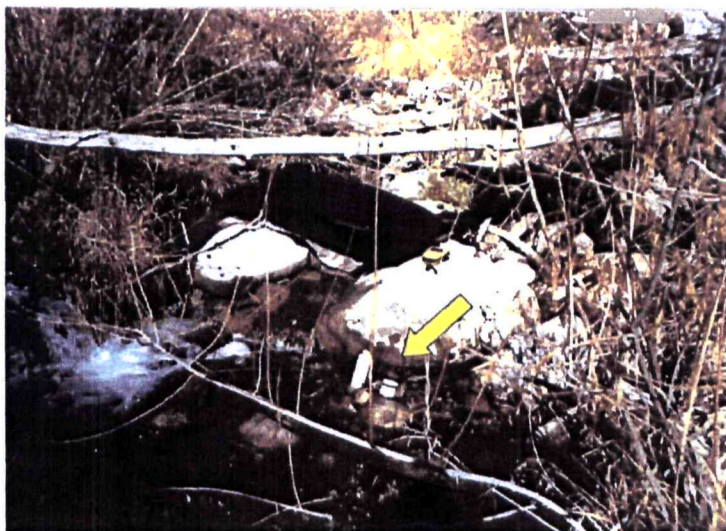
Photo 1-9. Date: 11/02/01. Sample: SD-77/SW-29.
View: Sample (see arrow) from Alexander Canyon.

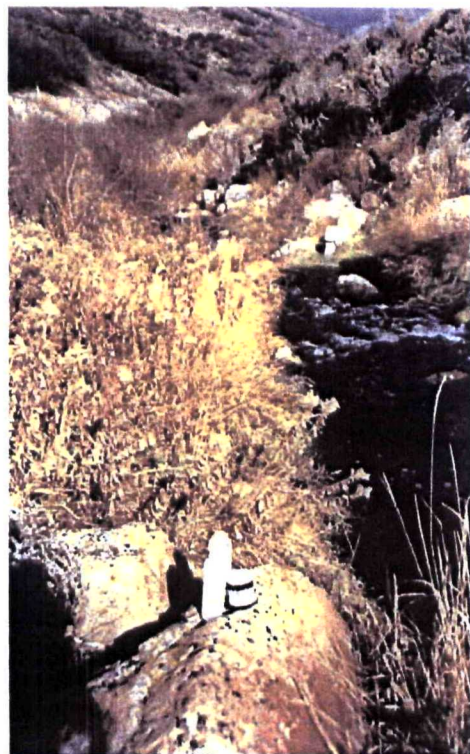
Photo 1-11.
Date: 11/02/01
Sample: SD-49/SW-19, SW-27.
View: to the north and samples collected in Silver Creek near an I-80 overpass (above Silver Creek).

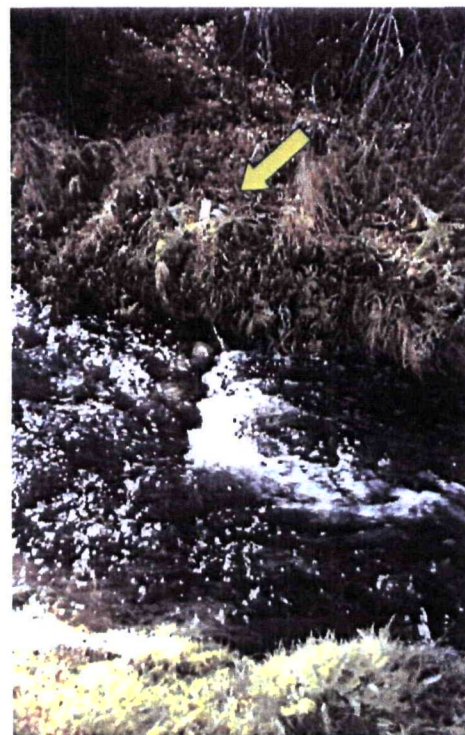
Photo 1-12.
Date: 11/02/01.
Sample: SD-48/SW-18
View: Samples on far bank (see arrow) of Silver Creek. An overview of sample site is shown in Photo 1-13.

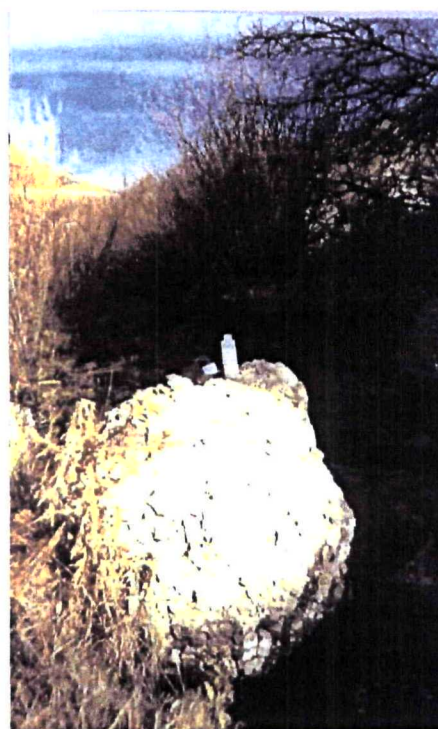
Photo 1-14.
Date: 11/02/01
Sample: SD-47/SW-17
View: North along Silver Creek, samples on a rock near the creek.

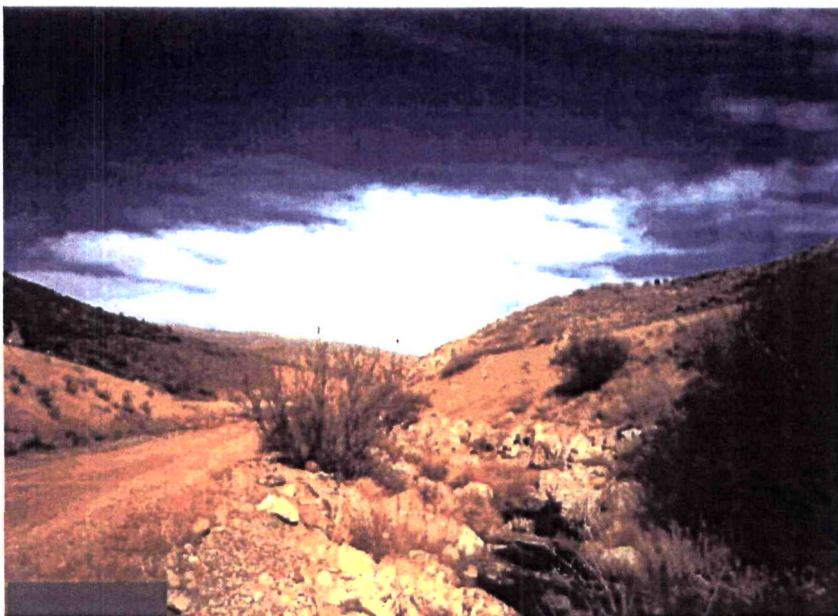
▲ Photo 2-2.
Date: 11/02/01
View: An overview to the north
of sample site SD-44/SW-14
(Photo 2-1).

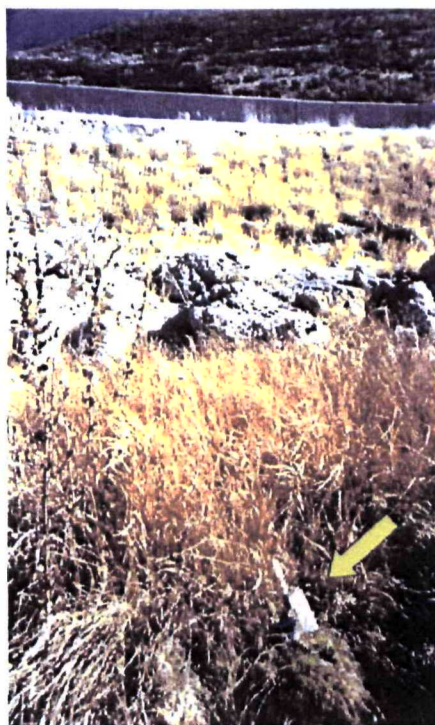
Photo 2-4.
Date: 11/02/01
Sample: SD-42/SW-12.
View: of the samples (see
arrow) located on the grassy
bank below a barracade for
I-80. Rainbow trout were at
this sample site.

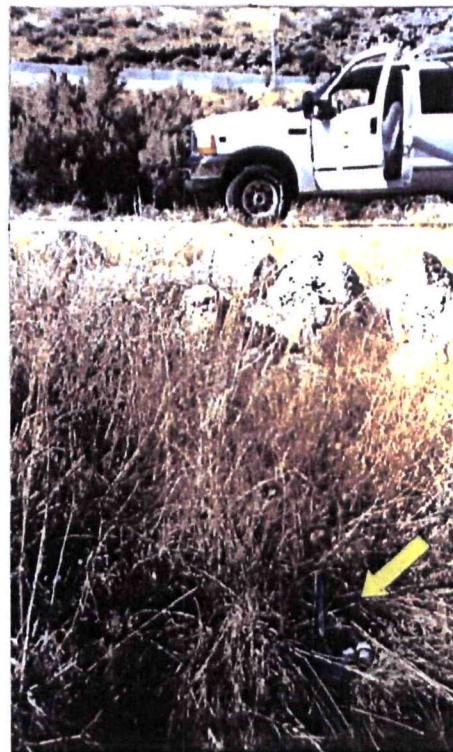
Photo 2-3.
Date: 11/02/01
Sample: SD-43/SW-13.
View: Samples on the bank of Silver Creek
near Rail Trail marker number 8. The
samples collected are located in the tall
grass on the banks of Silver Creek (see
arrow).

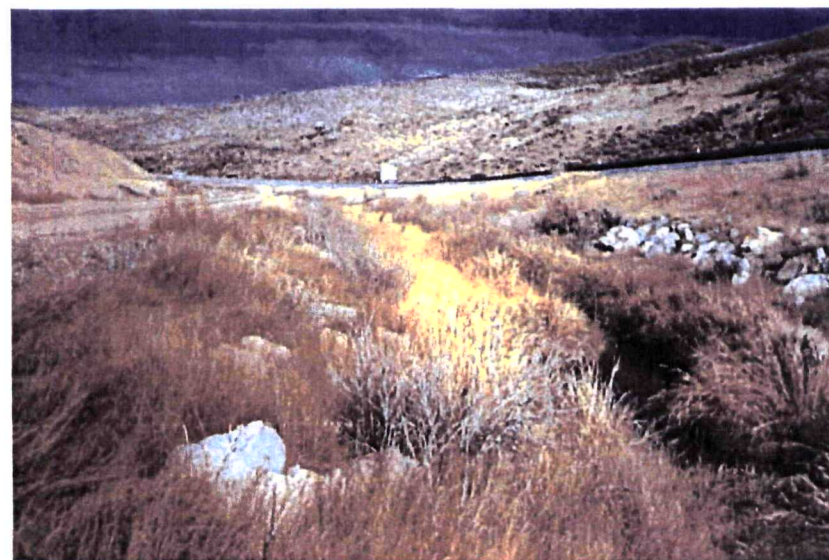
▼ Photo 2-5.
Date: 11/02/01.
View: An overview to the north of
sample site SD-42/SW-12 shown in
Photo 2-4.

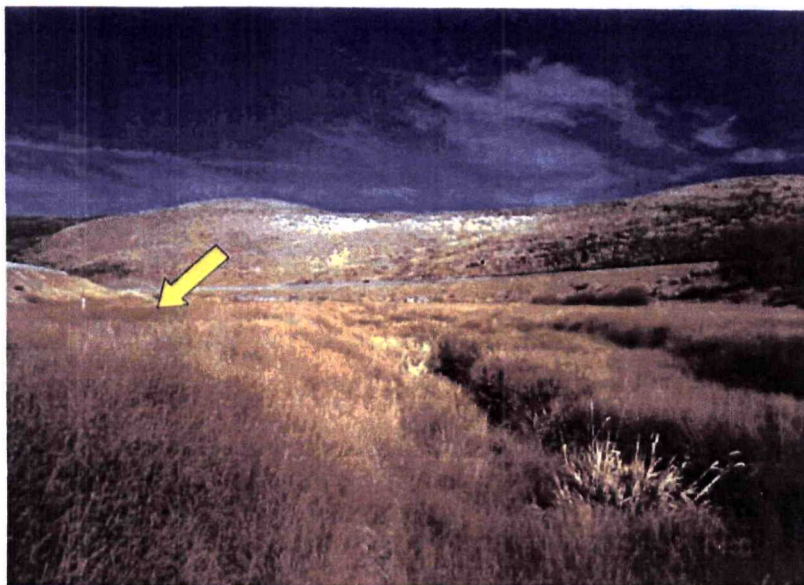
▲ Photo 2-6.

View: The sediment in Silver Creek at the sample site is fine grained. The samples are on the grassy bank as indicated by the arrow.

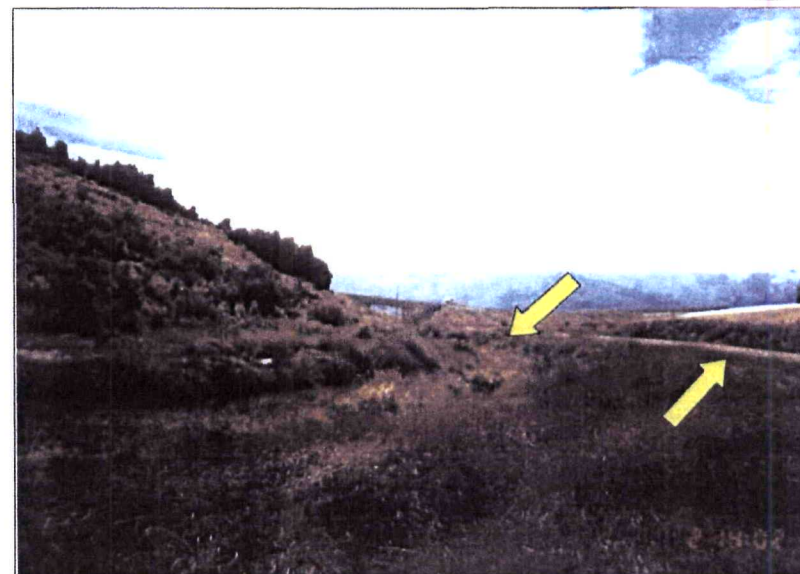
Photo 2-7. Date: 11/02/01. View: An overview to the north. Sample sites SD-41/SW-11 and SS-78 are located at the base of the slope on the left (see arrow). The I-80 overpass is shown in the background. The Rail Trail is on the right (arrow pointing up).

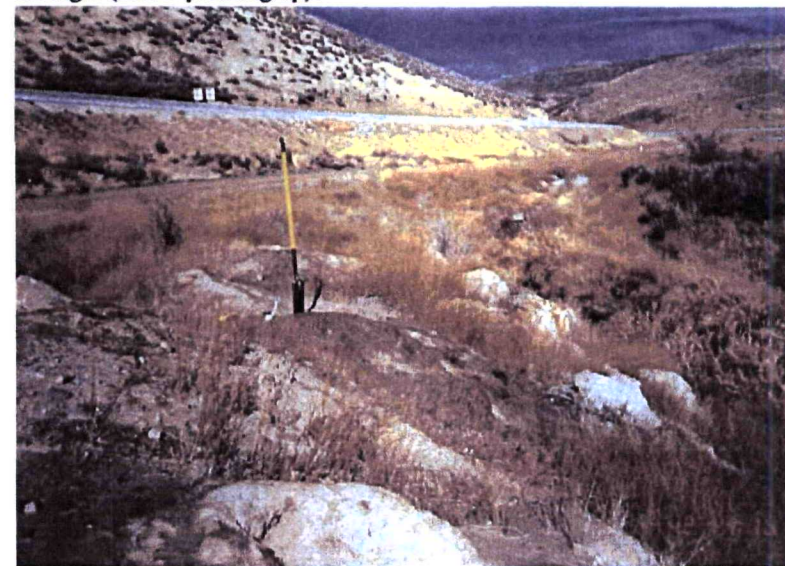
Photo 2-9. Date: 11/02/01. Sample: SS-78.

View: to the north with the sample site is on mounds adjacent to Silver Creek, which is on the right, and the sample site of SD-41/SW-11.

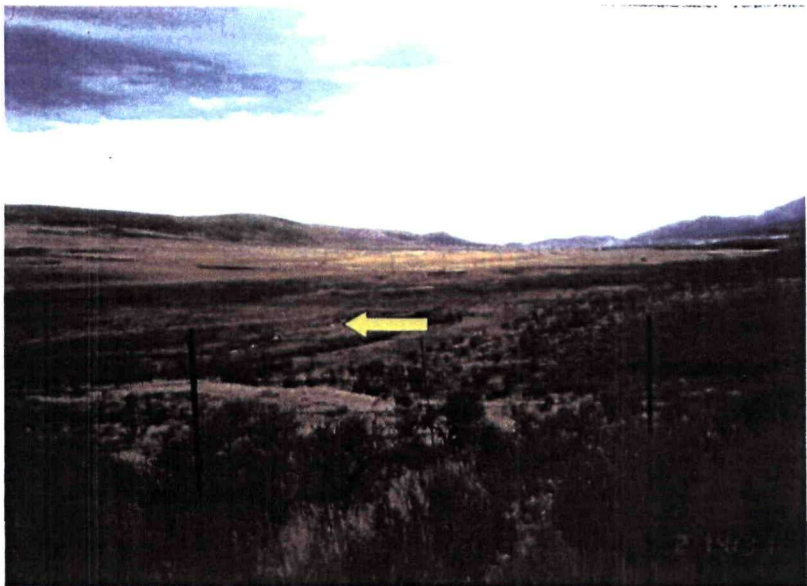
Photo 2-10. Date: 11/02/01. View: to the SE and the southern portion (meadow area) of the LSC Site taken from the service road, which leads to the Pace ranch buildings at Atkinson. The photo was taken from the approximate site of the historical Pace family homestead. The arrow indicates the location of Silver Creek.

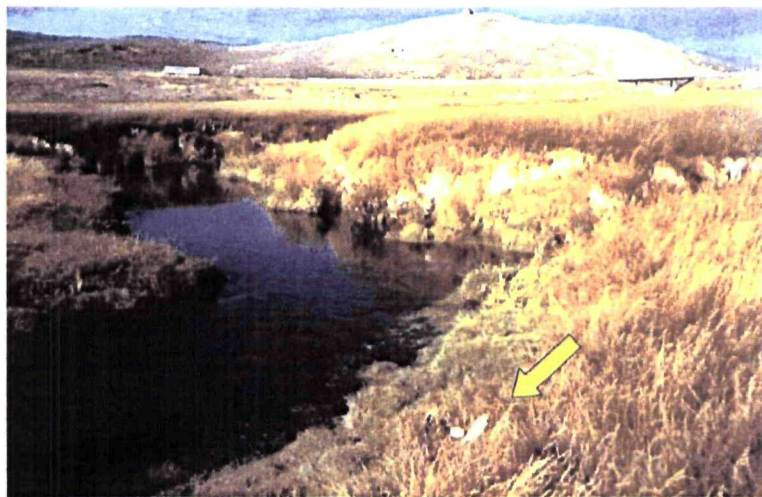
Photo 2-12. Date: 11/02/01. Sample: SD-40/SW-10. View: to NW of the sample site. Silver Creek flows through the center of the meadow at this point, I-80 is in the background and the water treatment facility is to the far left of the photo. The arrow indicates the samples collected.

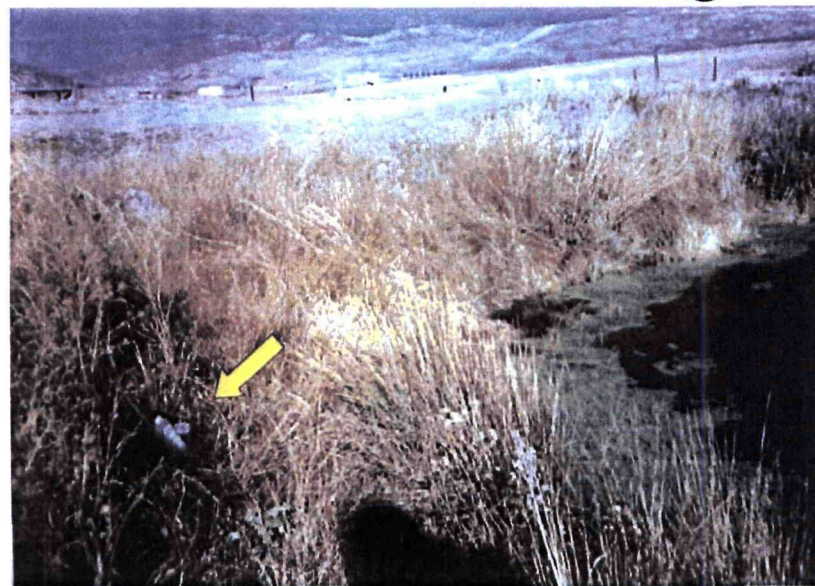
Photo 2-11. Date: 11/02/01. Sample: SD-79/SD-30. View: to the NE of sample site on Silver Creek near the water treatment facility (behind the photographer). The arrow indicated the samples collected.

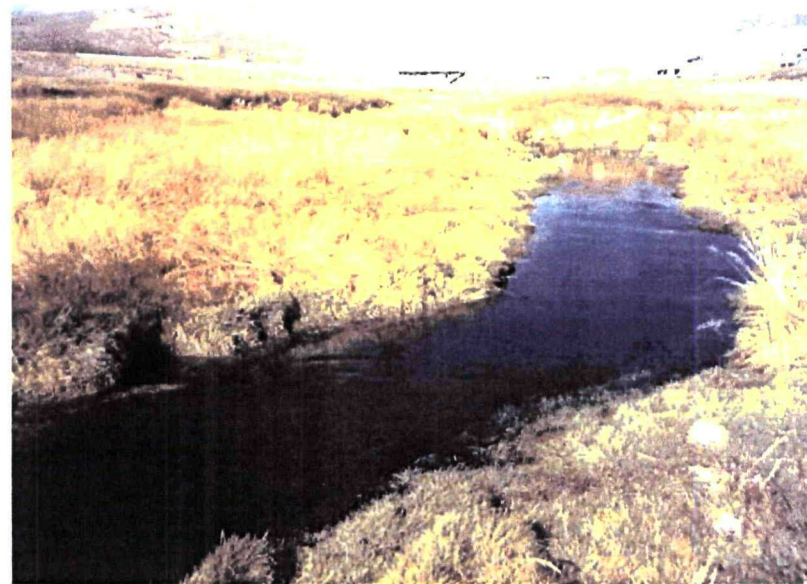
Photo 2-13. Date 11/02/01. View: over view of photo 12, terraced banks of Silver Creek, ducks were observed in the creek as the sampling crew approached. The lower left corner shows the long grass observed in the creek.

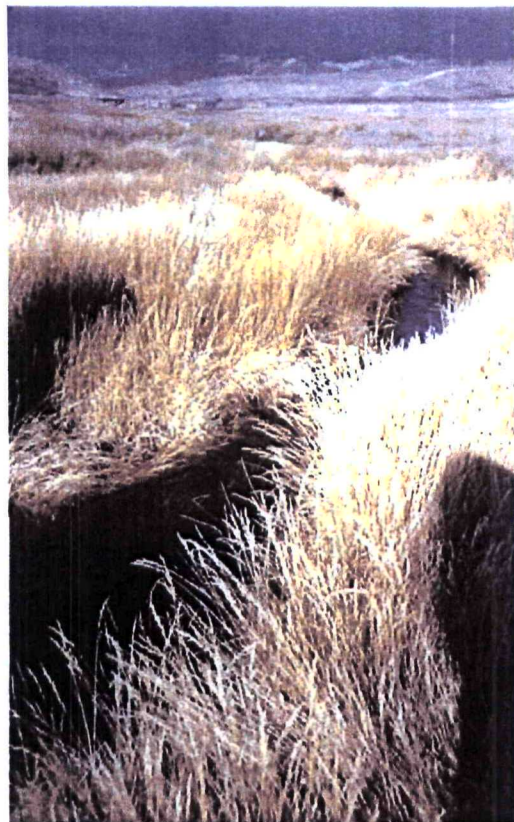
Photo 2-14
Date: 11/02/01.
Sample: SD-39/SW-09.
View: of Silver Creek to the north with the I-80 in the background. At this site the creek bottom is gravelly and the banks are covered with the grass the cattle like to eat.

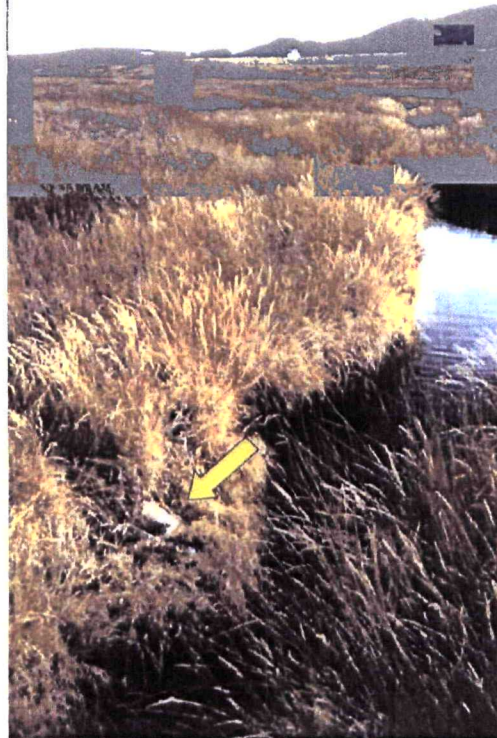
Photo 2-15.
Date: 11/02/01.
Sample: SD-38/SW-08.
View: of Silver Creek to the SW with the Sheriff's facility in the background. The arrow indicates the sample site.

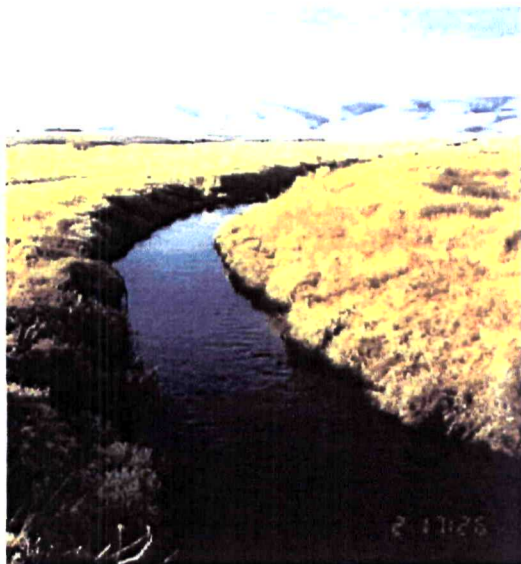
▲ Photo 2-18. Date: 11/02/01.
Sample: SD33/SW-03
View: to the NW of the sample site and the Pace-Homer Ditch located east of the Rail Trail.

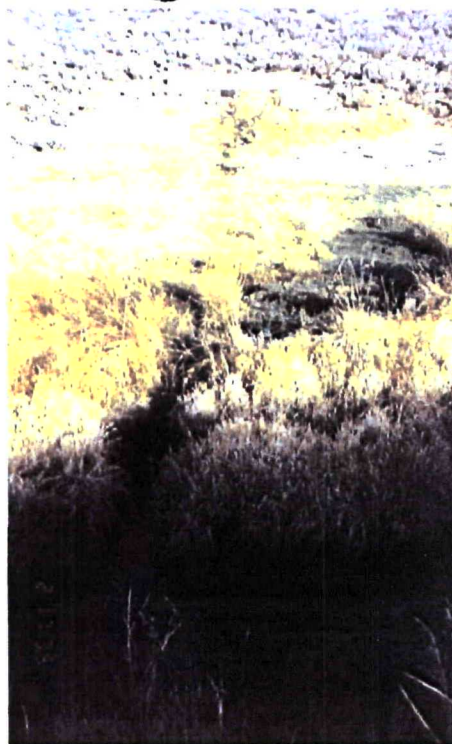
Photo 2-19.
Date: 11/02/01.
View: to the east of the Homer Spring emerging from the cement wall and flowing straight down to the Pace-Homer Ditch in the foreground, which is near the (SD-32/SW-02) sample site.

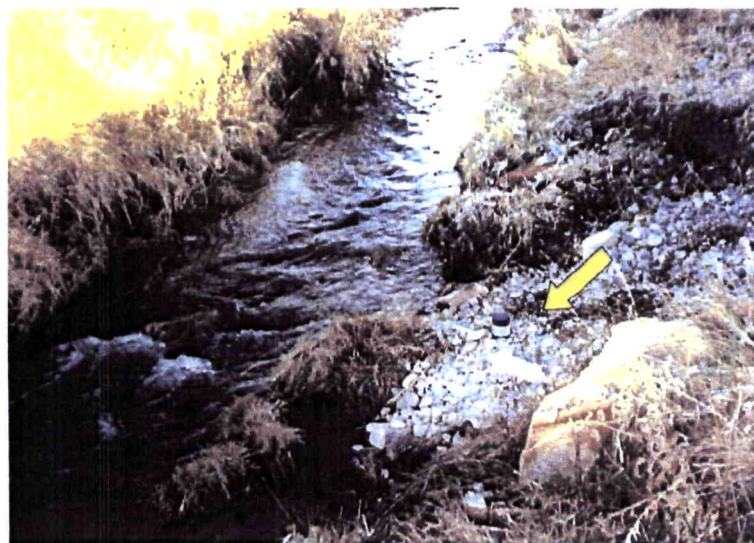
Photo 2-20.
Date: 11/02/01.
Sample: SD-32/SW-02.
View: the Pace-Homer Ditch and sample site, which is immediately upstream from Homer Spring (to the right of the Photo 2-19).

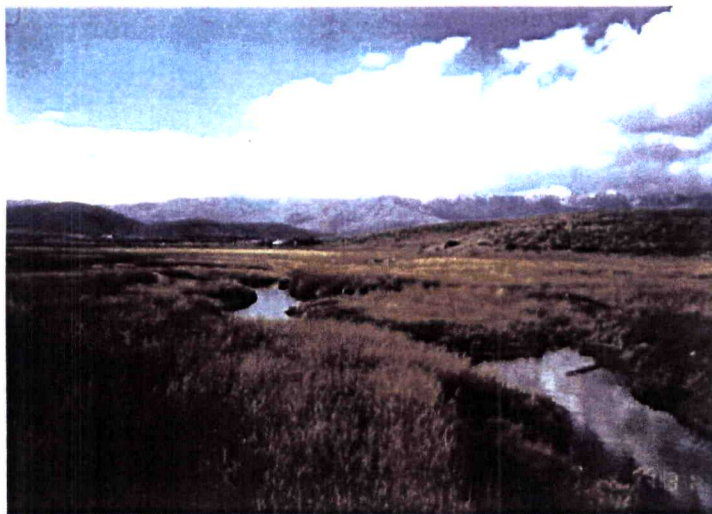
Photo 2-22. Date: 11/06/01. Sample: XRF66 and SS-56.
View: to SW and water treatment facility in center of photo, the access road to Atkinson (Pace ranch buildings near I-80) is to the right of the photo. Ducks were observed at the sample site.

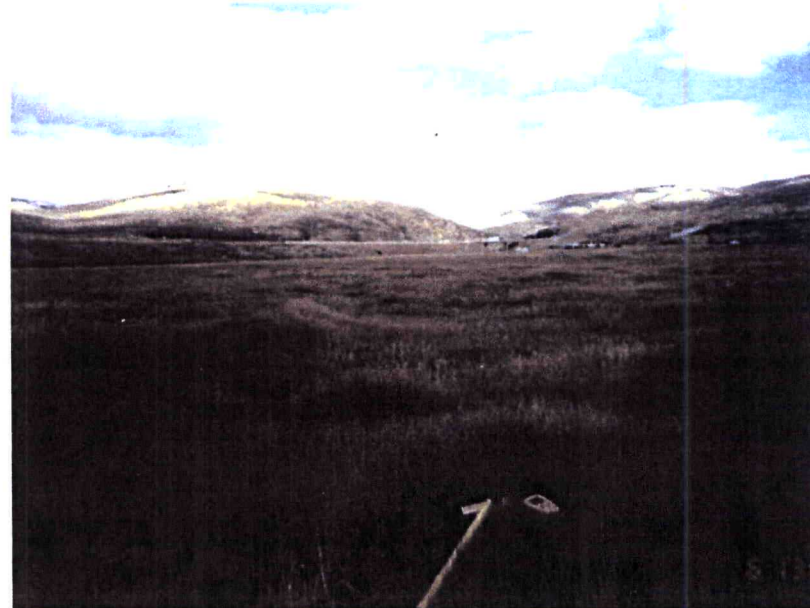
▲ Photo 2-25. Date: 11/06/01.
Sample: XRF74
View: to north, hummocky mounds covered with wire grass in the foreground, Atkinson and I-80 are in the background.

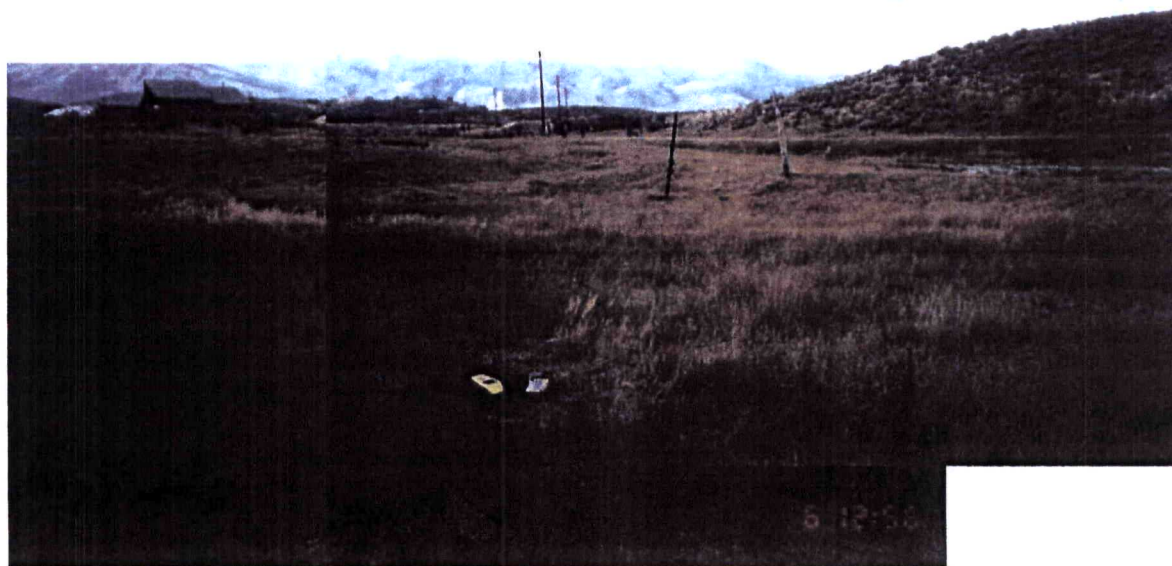
Photo 2-23 and 2-24. Date: 11/06/01.
Sample: XRF72 and SS-57
View: to SW and the water treatment facility to the left in the background, a corral is in the center background, and a ranch access road is to the right in the background. The sample site is in a grassless spot surrounded by wire grass.

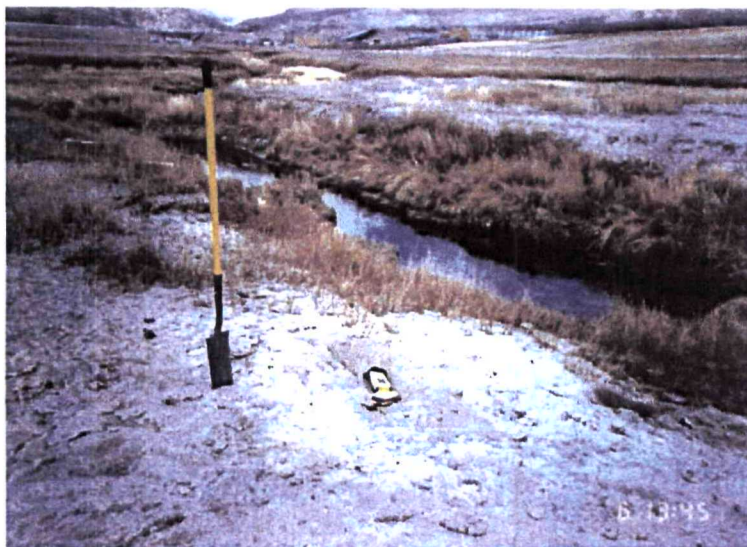
▲ Photo 3-1. Date: 11/06/01.
Sample: XRF 75

View: Sample site on a sandy berm adjacent to Silver Creek, and west of the historical Big Four Mill site. Atkinson is to the north at the top of the photo near I-80. Standley Pace visited the sampling crew at this point and remarked the tailings are 5 feet deep in that area.

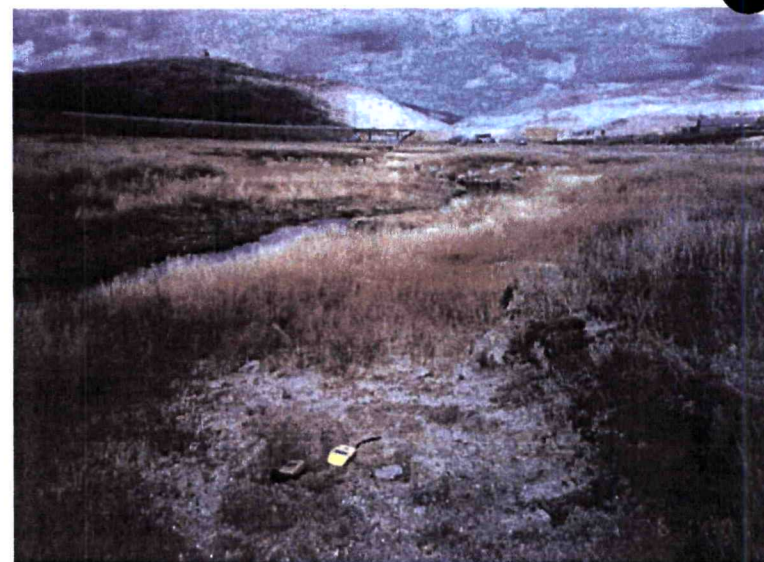
▲ Photo 3-2. Date: 11/06/01
Sample: XRF77

View: to the north, sample is on sandy grassless (foreground) terrace adjacent to Silver Creek.

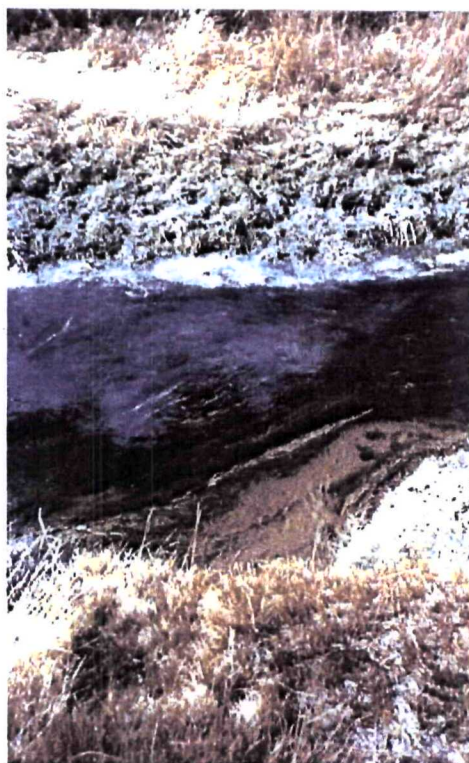
Photo 3-3. Date: 11/06/01.

View: of Silver Creek near sample site (XRF78, shown in Photo 3-4), which is to the right of the photo.

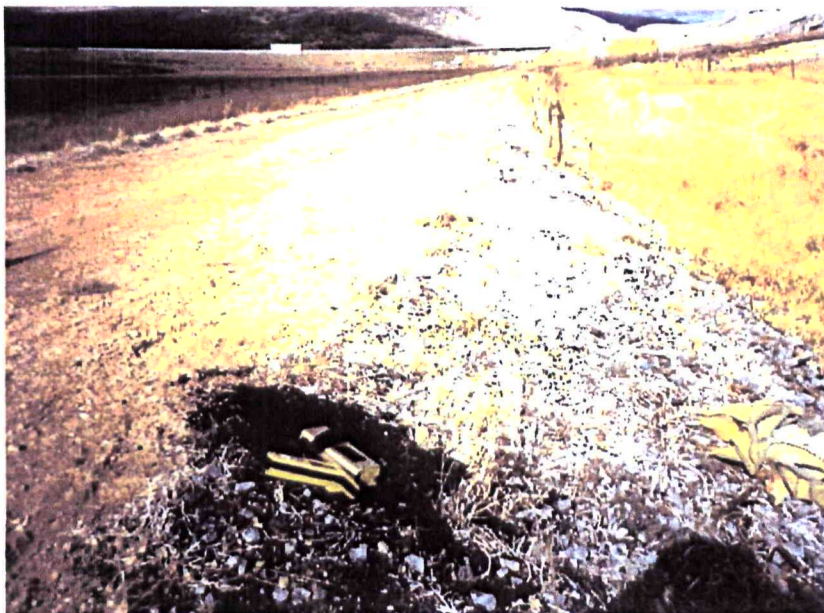
▲ Photo 3-5. Date: 11/06/01. Sample: XRF79.
View: along the east side of the Rail Trail looking to the north.

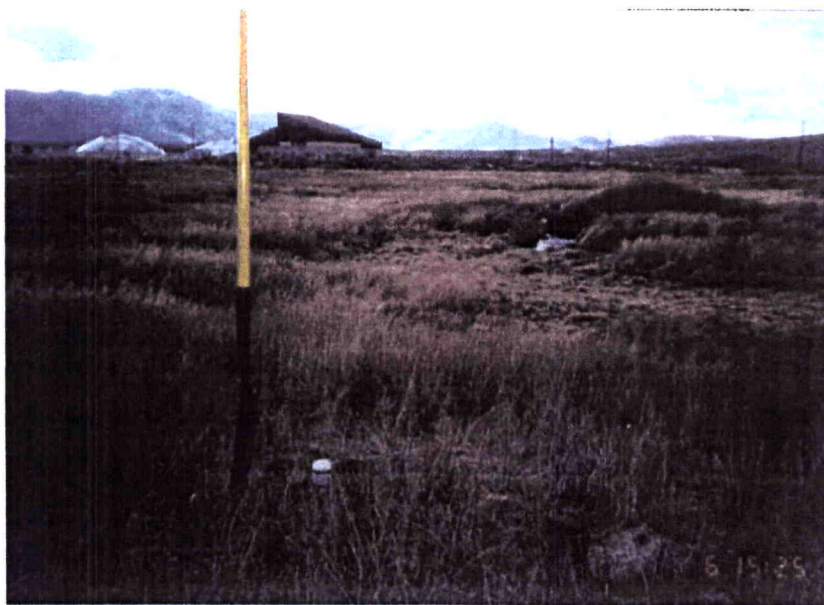
Photo: 3-7. Date: 11/06/01.
Sample: XRF83 and SS-58.
View: sample site is surrounded by wire grass and is downstream from the water treatment facility, which is in the background. At this site ducks and fish were observed in the creek.

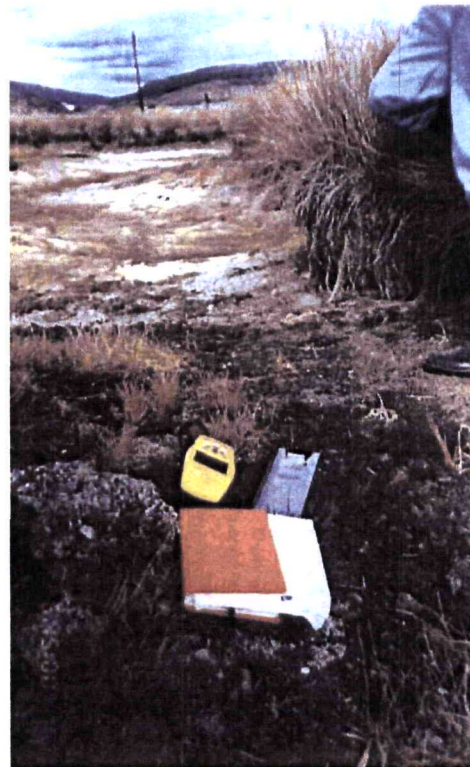
Photo 3-6. Date: 11/06/01.
Sample: XRF81.
View: sample site within a depressional area with an 18-inch drop below the surrounding surface, sample was moist.

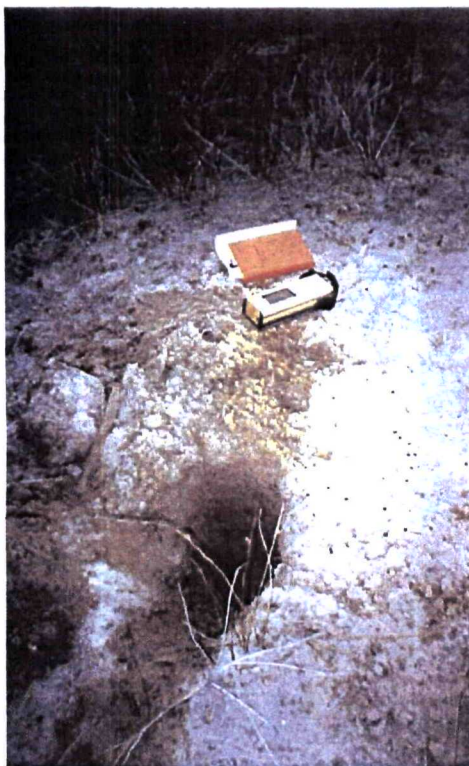
Photo 3-9. Date: 11/06/01.
Sample: XRF88 and XRF89.
View: XRF88 is taken from undisturbed soil and XRF89 is on material apparently excavated from an existing hole that had a depth of one foot. The two sample spots are three inches apart.

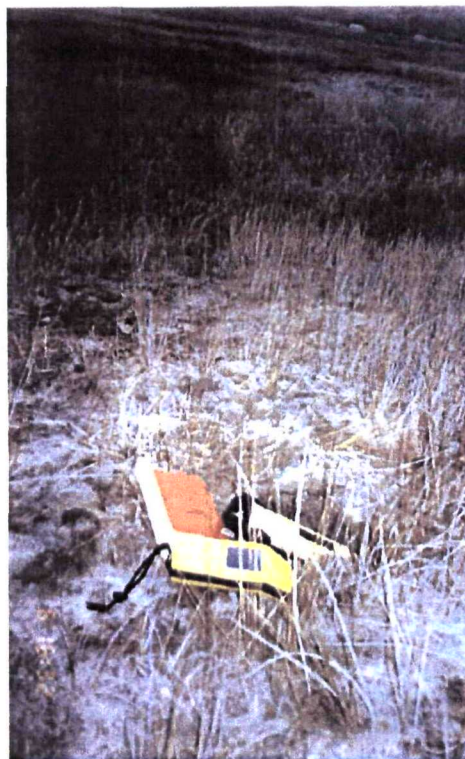
Photo 3-10. Date: 11/06/01.
Sample: XRF91
View: of the sample site on a terrace on the east side of Silver Creek in sandy soil surrounded by wire grass located near a fence.

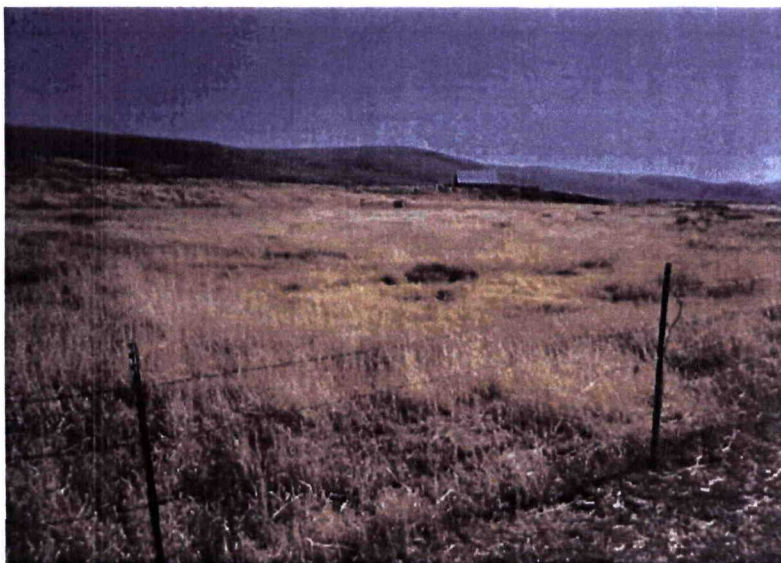
Photo: 3-13. Date: 11/08/01. Sample: XRF106.
View: to SE within the fenced area that is reportedly a proposed mitigated wetland. In the background, on the hill, is a Pace ranch building (adjacent to Promontory Road) and the historical site of the Big Four Mill.

One of the parcels not sampled, due to the a lack of an access agreement prior to the time of sampling, is located north of the Pivotal Promontory access road and west of the historical Big Four Mill site (Photo 3-13, Appendix B). The aforementioned parcel is reportedly part of a wetland mitigation agreement to build a road across the wetlands (Promontory Road) that included the planting of several trees that died apparently due to poor soil conditions⁵. A frog species was also introduced to the mitigated wetland and apparently did not survive⁵.

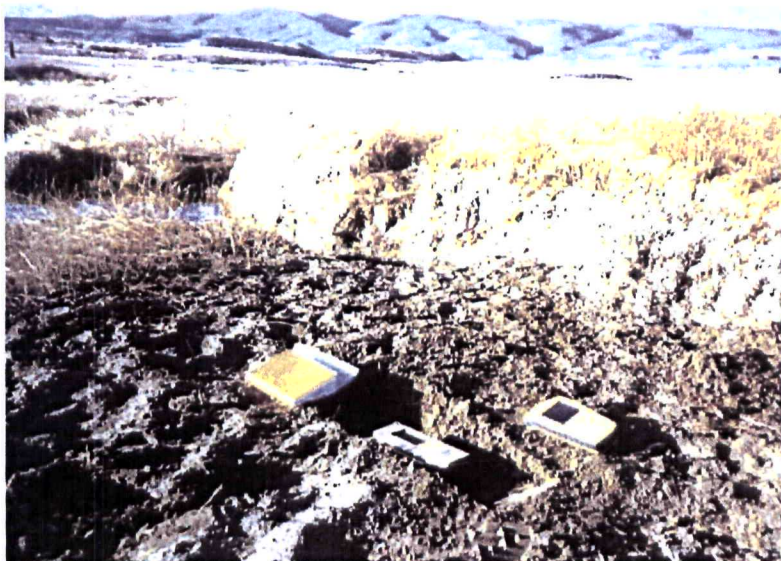
Photo: 3-15. Date: 11/08/01. Sample: XRF122.
View: to the NW at a grassless sample site on a terrace on the east side of Silver Creek, sample depth is three inches.

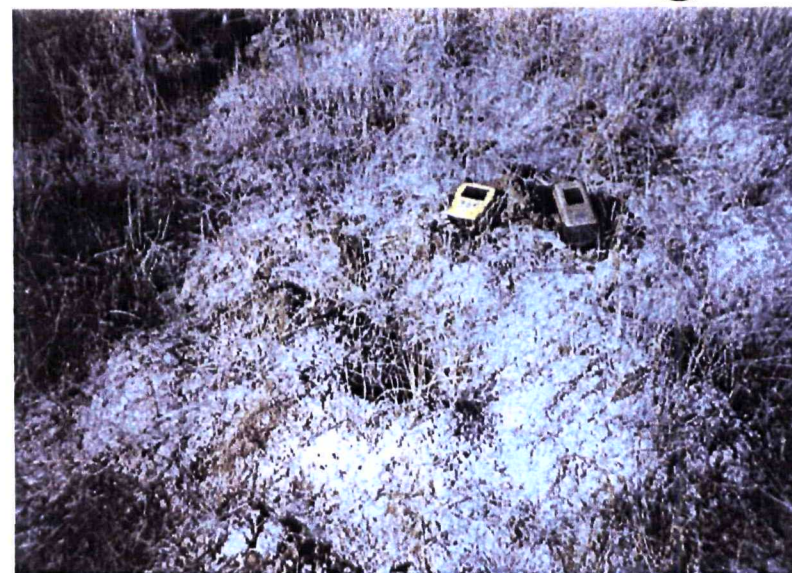
▲ Photo: 3-14. Date: 11/08/01.
Sample: XRF108.
View: sample site in a hummocky area between a fence line and Silver Creek within a wire grass area.

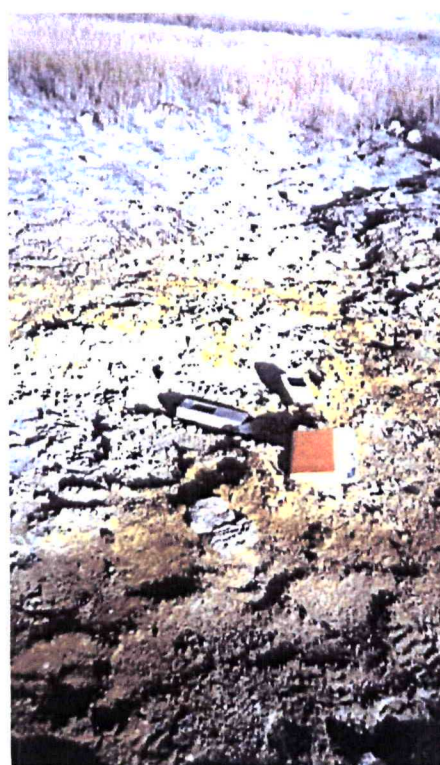
Photo: 3-16. Date: 11/08/01.
Sample: XRF124 and XRF125.
View: sample site is east of Silver Creek on a terrace. XRF124 is in a yellow/red sandy soil and XRF125 is in the red sandy soil, which formed a circle around XRF124.

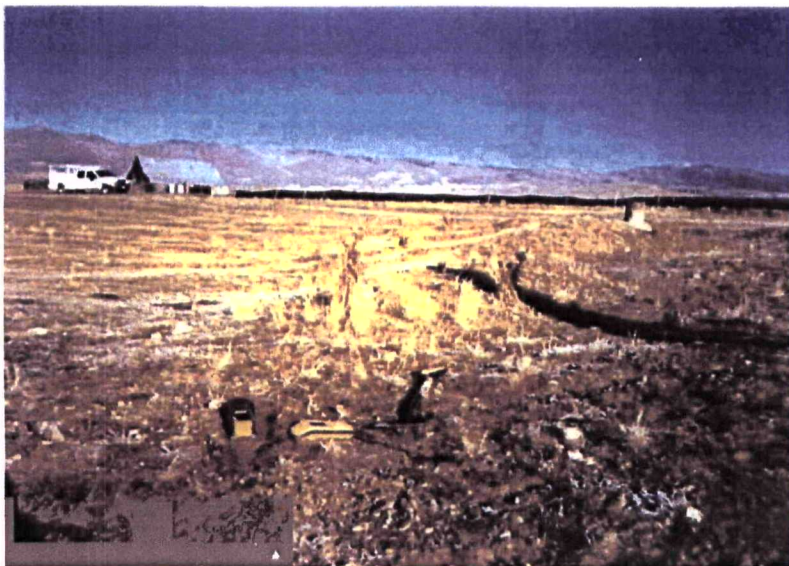
Photo: 3-17. Date: 11/09/01. Sample: XRF132.
View: to the north with the Pace farm building along Promontory Road in the background.

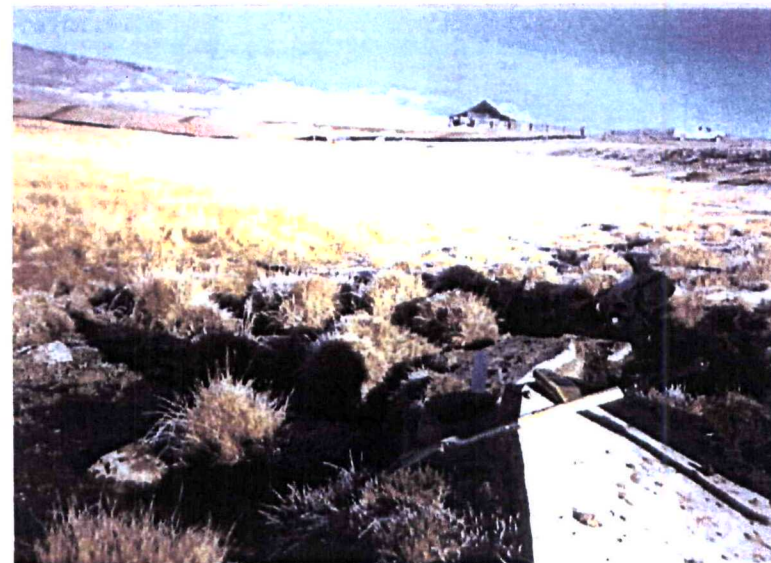
Photo: 3-18. Date: 11/09/01. Sample: XRF133 and SS-61, SW-06.
View: to the north at the spring, which was historically used in the Big Four mill processing. (The Pace farm building is shown in the background.)

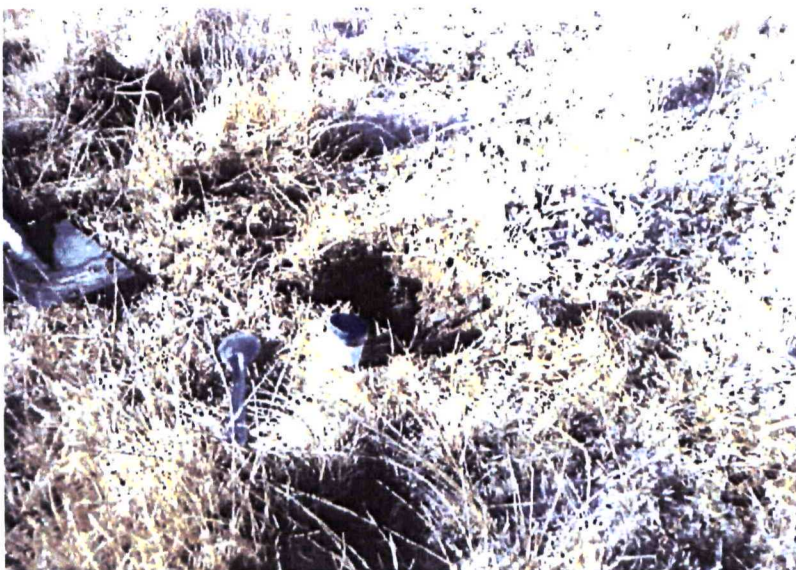
Photo: 3-19. Date: 11/09/01. Sample: XRF133 and SS-61
View: close up of the soil and XRF sample site. The surface water sample was taken from the spring to the right of the photo, as shown in Photo3-18.

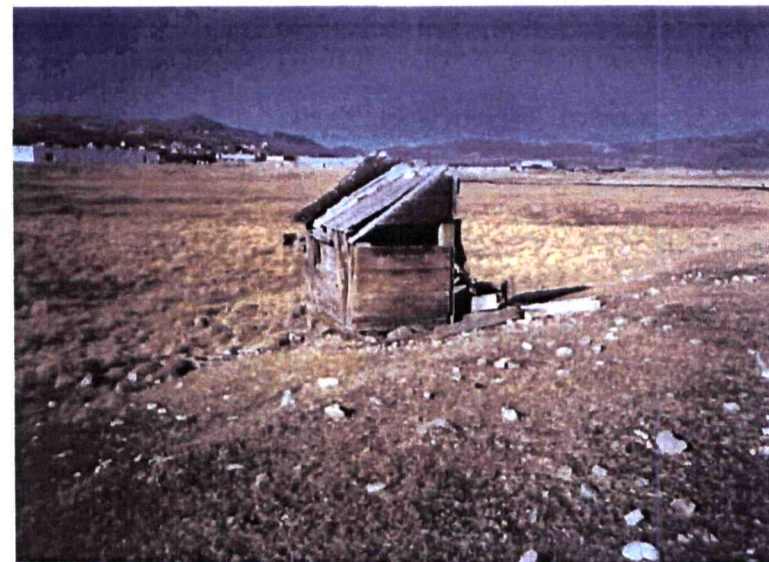
Photo: 3-20. Date: 11/09/01. Sample: XRF134.
View: to the west of the sample site with an old pig house in the center of the photo and the Sheriff's facility in the background. Near the pig house was moist soil, which may be the result of a seep.

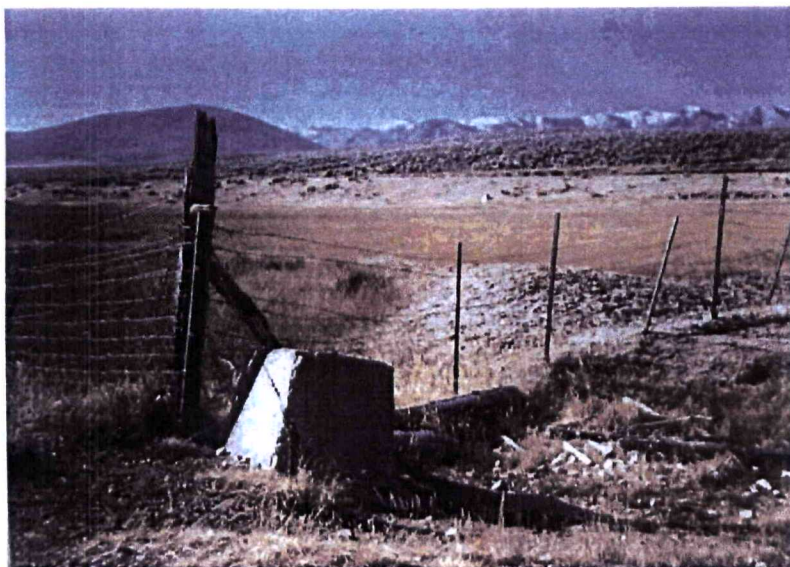
Photo 3-21. Date: 11/09/01. Sample XRF140 and SS-62.
View: to the SW at the property boundary and fenceline (F. Gilmore), the surrounding area has hummocky grass clumps, and saturated soil. Samples were taken from the berm to right of the fence.

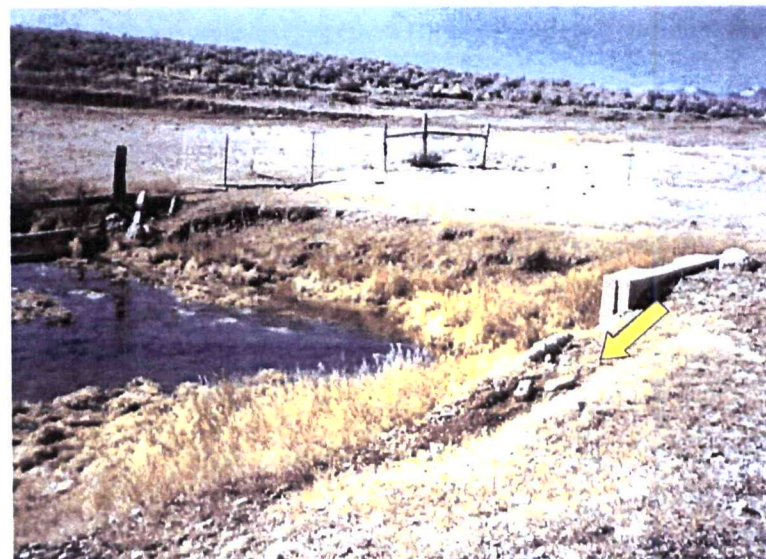
Photo: 3-22. Date: 11/09/01. Sample: XRF141.
View: to the SW, samples were taken from the material excavated from an existing hole on the side of a dirt road that crosses over Silver Creek.

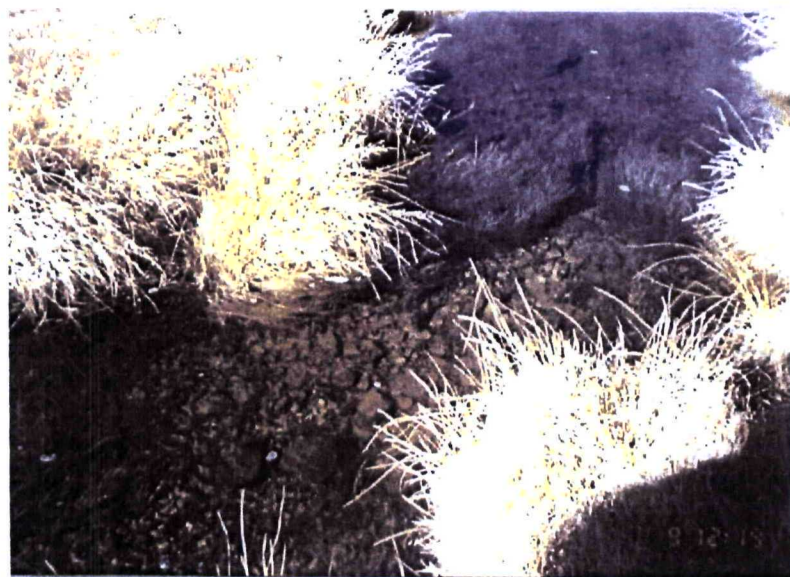
Photo: 3-23.. Date: 11/09/01. Sample: XRF144.
View: of Silver Creek showing a cobblesized rocky bottom and a width of three feet. The sample site is to the east of the creek on a sandy grassless berm, and to the east is a saturated hummocky area with red soils.

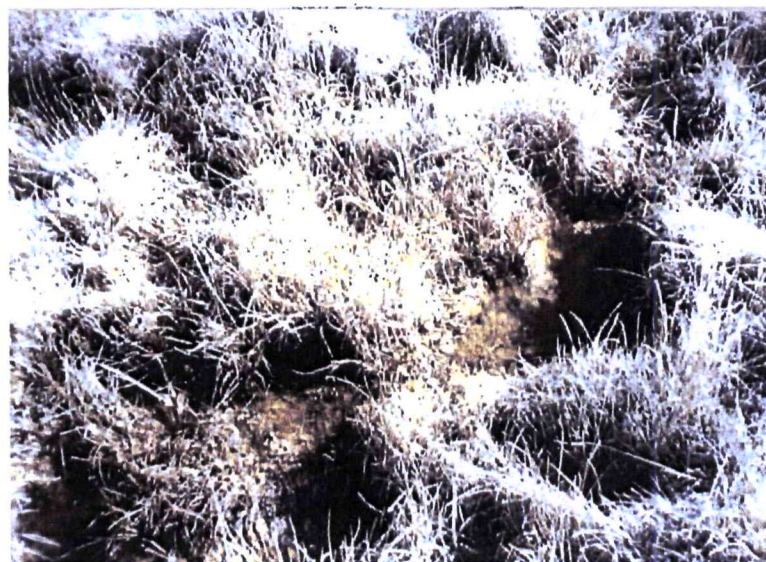
Photo 3-24. Date: 11/09/01.
View: of standing water in hummocky area near XRF144 and XRF145.
